## 1.0 INTRODUCTION

This document describes an errata for the XR28V38x LPC UART family, customers who will be affected, the root cause of the errata, the severity of the errata and suggested work-around(s) for the errata.

XR28V38X ERRATA

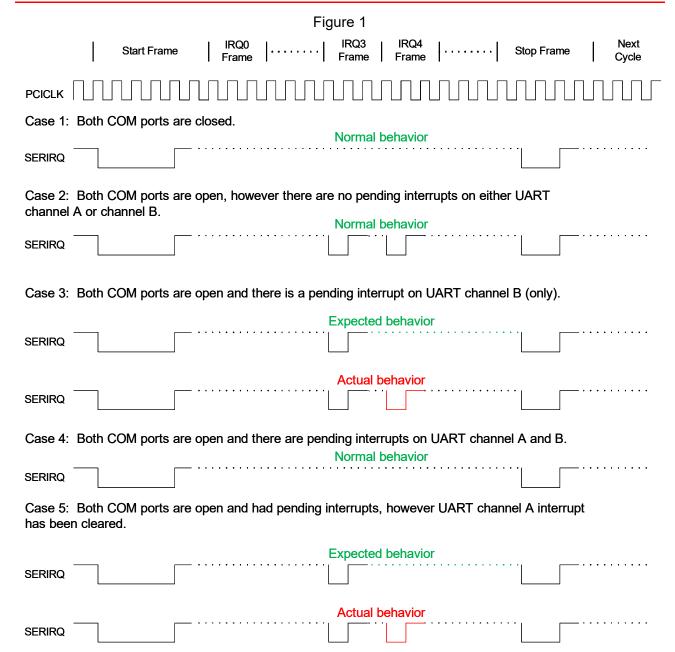
When all 3 of the above conditions are met, the SERIRQ pin does not generate interrupts as depicted in Figure 1 on page 2. Figure 1 uses 2 channels as an example and the definitions of open and closed UART channels.

Error when IRQ Channel Select Register bit [6:4] = 000 is the root cause of this issue.

The severity of this issue is low as there is an alternate setting which correctly generates interrupts with the same polarity.

The work-around for this mode is to program the IRQ Channel register bits [6:4] to '101. In this mode, all incorrect behavior is eliminated.
